Inspection Report
Minerals Regulatory Program
Report Date October 19, 2005

Mine Name: Velvet
Operator Name: U. S. Energy

Permit number: M/037/040
Inspection Date: August 18,
2005
Time: 5:50-6:15 PM

M/037/040, Velvet Mine, U. S. Energy

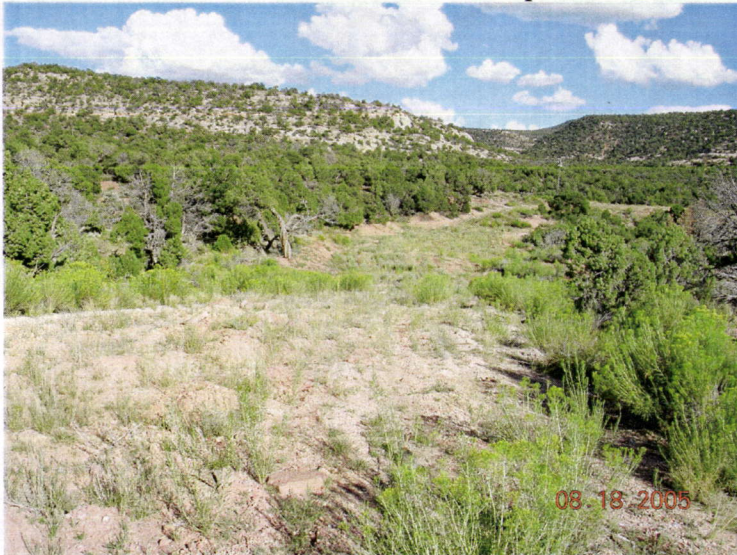
It has now been nearly two years since the site was graded and seeded. Vegetation is progressing well, particularly on the pad where topsoil was spread (Photos 1 and 3). It is more sparse on the outslopes (Photo 2), but I believe it will continue to fill in.

Photo 1. The entrance road.

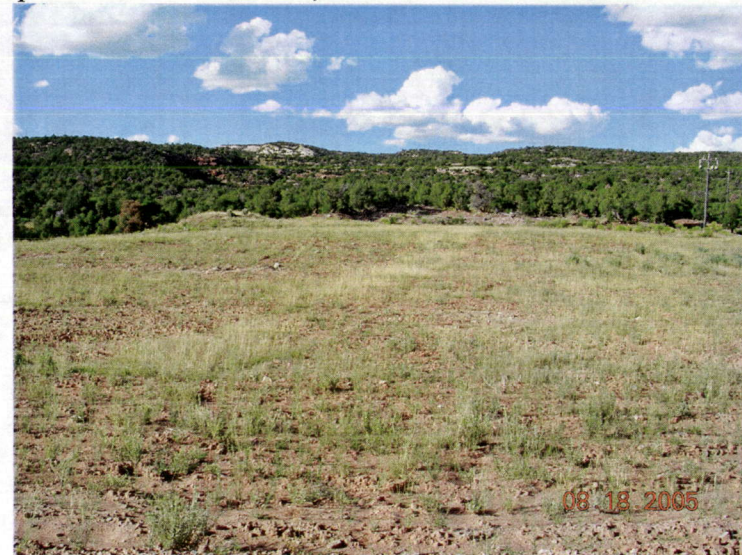
Photo 3. A view of the pad.

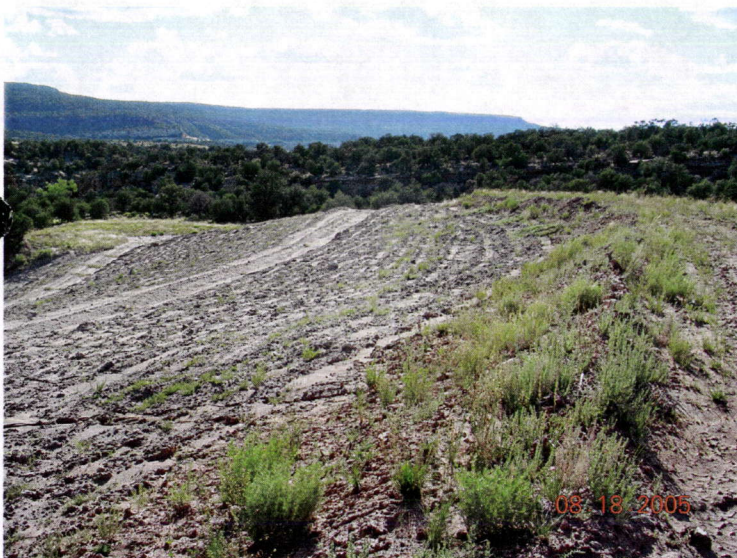
Photo 2. The outslope (left) and the pad (right). Note the difference in vegetation between the area that received topsoil and the area that did not.

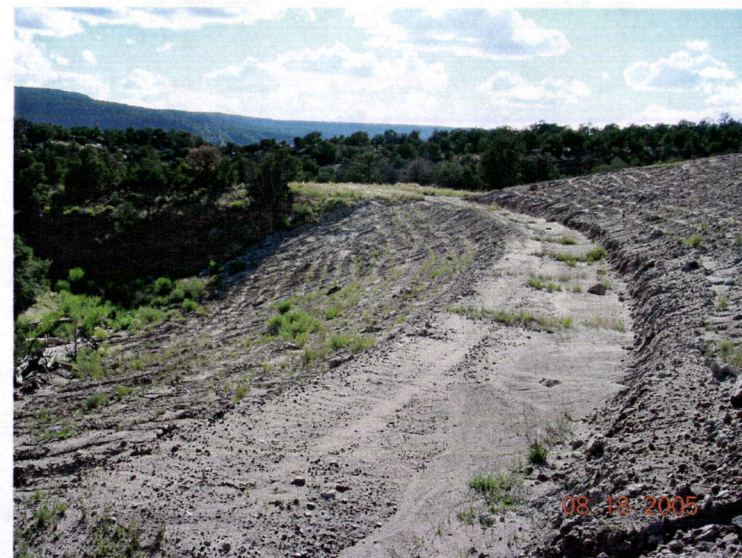
The area has apparently had significant rain this summer, but while there has been some erosion on the outslope, it has not been significant. Because of the terraces (Photo 4), little sediment has traveled off site.

Of interest are the places where manure was spread. The manure was not spread evenly, and in 2004, one could easily see the places where manure was applied based on the weeds. This year, the weeds are almost entirely gone, and these places clearly have the best vegetation cover of any places on the outslopes (see the vegetated areas on the terrace in Photo 4).

Photo 4. One of the terraces on the outslope, Note the patches of vegetation on the terrace where manure was applied.
